Procedia Engineering 108 (2015) 93 – 101

7th Scientific-Technical Conference Material Problems in Civil Engineering (MATBUD'2015)

## Research methods adopted for evaluation of the condition of the building materials used in construction of the masonry structures on the site of the Auschwitz-Birkenau State Museum in Oświęcim

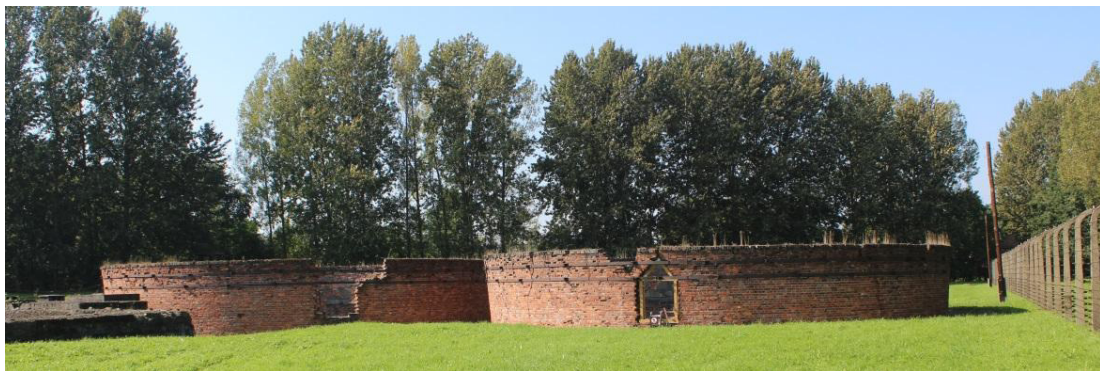
Fig. 1. The trickling filters of the camp sewage treatment station – current condition.

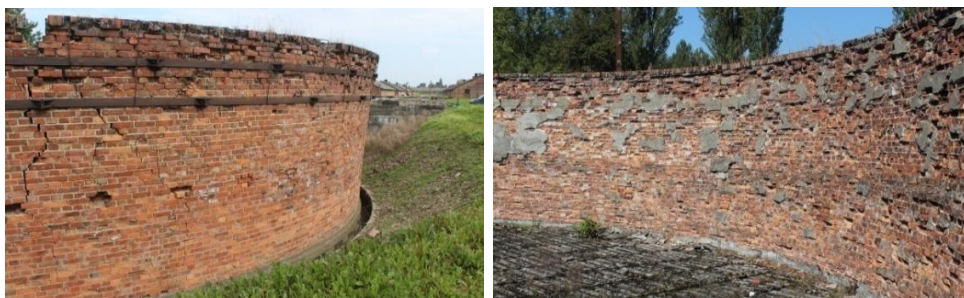
Fig. 4. The trickling filter – view from the outside, view from the inside (from left to right).

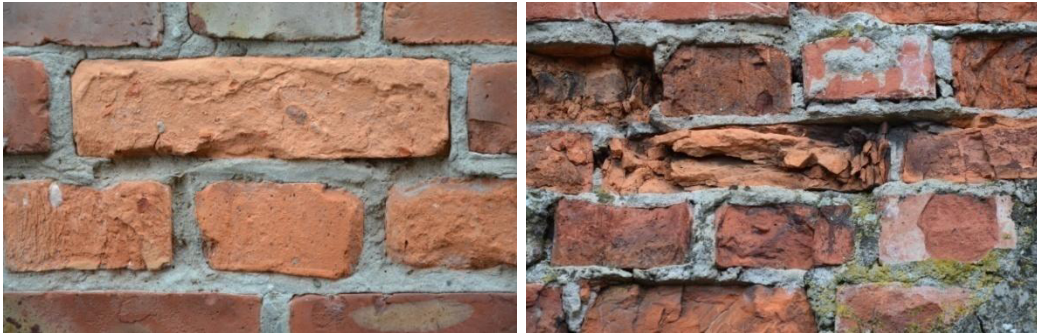
Fig. 5. Macroscopic image of the wall damage.

On the basis of macroscopic observations it has been found that the degree of damage is greater in the case of the ceramic brick than in the case of the mortar. The process of mortar degradation was related inter alia to binder carbonation, leaching of soluble ingredients, including calcium hydroxide, and to the emergence of both readily soluble substances, which were then easily leached, and insoluble products increasing the volume. The visible effect is loosening of the mortar texture and crumbling.

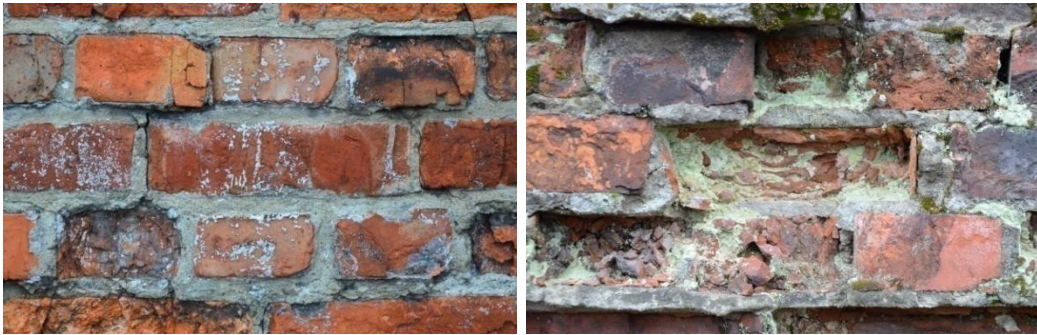
Fig. 6. Macroscopic image of efflorescence formations and microorganisms present at the surface of the wall (from left to right).

Examination of the microstructure of the destroyed ceramic bricks indicated loosening of texture with clear peel-off surfaces. The presence of ettringite and calcium carbonate was observed as well as numerous cracks. Chemical analysis of efflorescence on the wall surface carried out with the use of EDS confirmed the presence of gypsum and calcium potassium sulphate as its primary components. Another destructive factor was the presence of microorganisms, such as moss, lichen and fungi.

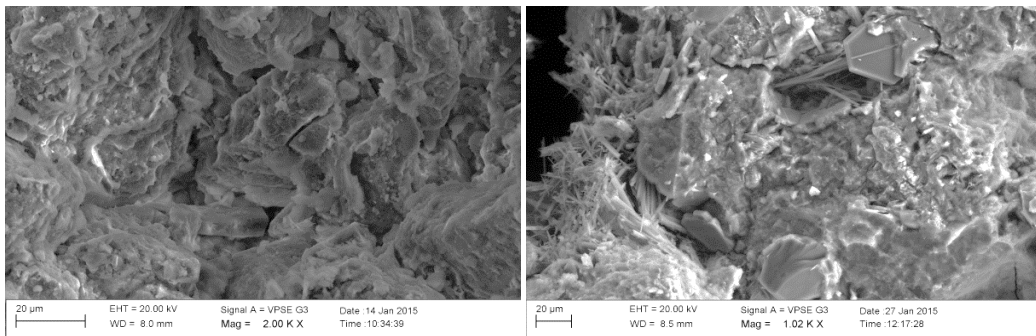
Fig. 7. An example image of the microstructure of the degraded bricks and mortar (from left to right).

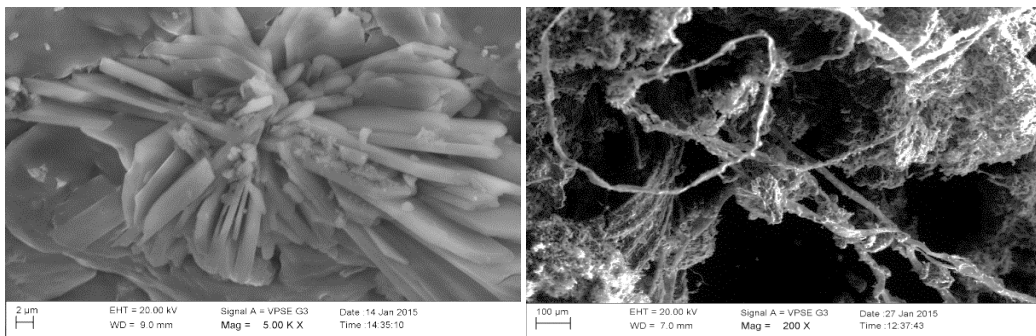
Fig. 8. An example image of the microstructure showing efflorescence and microorganisms on the surface of the materials (from left to right).
